Appraisal Of Habitability And Maintenance Of Public Residential Houses In Nigeria: A Case Of Crutech Staff Quarters, Calabar

Department of Architecture, Cross River University of Technology,
Calabar, Nigeria

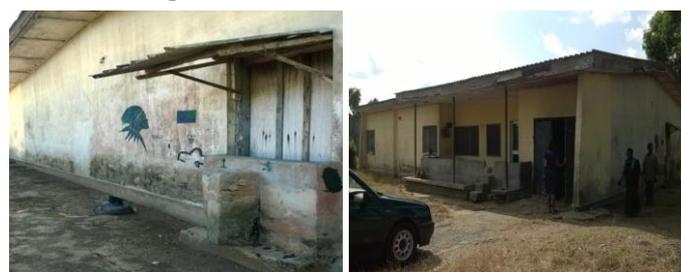
Plates I and II: Exterior view of two of the buildings in the study area

On the other hand, the data on the housing features, the results on the building type shows that 28 (56%) of the houses were 3bedroom detached apartment as shown in Plates I and II respectively while 22 houses (44%) are 2-bedroom detached bungalow.

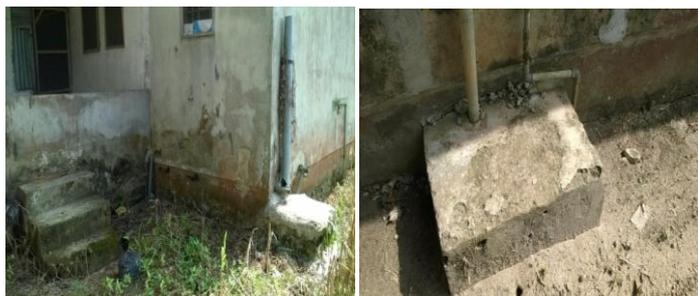
Plates I-II: Exterior view of state of repairs of the buildings

On the state of repairs of the houses studied, Table 1 reveals that 15 houses (30%) were dilapidated, 18 houses (36%) required major repairs and 14 houses (28%) required minor repairs while only 3 houses (6%) were in good condition. This indicates that 94% of the houses examined were dilapidated and requiring serious maintenance and therefore unfit for human habitation.

The investigation as revealed by the study could possibly affirm the causes of the defects. This include absence of drainage in some areas, poor drainage system,, roof leakages

due to old age, lack of preventive maintenance by the authority of CRUTECH and lack of corrective maintenance by the occupants. The study observed that the quality of the building materials used in the housing construction were of high standard which accounts for the over thirty long life span of the houses despite the lack of maintenance and years of flooding due to poor drainage system.

- ✓ Periodic (preventive) and corrective maintenance of buildings should be carried out in order to enhance the lifespan of buildings and prevent building failure.
- ✓ Construction of a well designed drainage system and constant cleaning of same to facilitate water runoff during wet seasons to prevent building decay.
- ✓ Qualified and experienced personnel should be engaged in the construction and maintenance of University Staff quarters and other public housing estates.
- ✓ Routine Checks should be carried out periodically in order to determine the conditions of the buildings for prompt maintenance to enhance liveability.

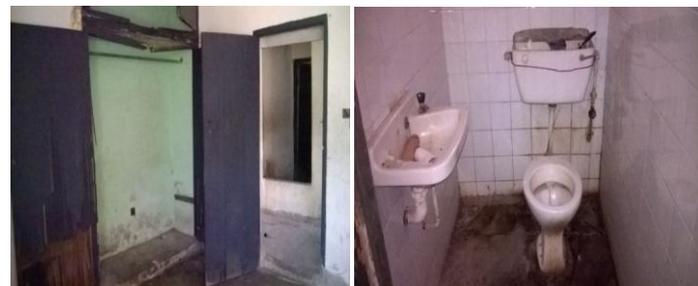
Plates III-IV: Interior view of state of repairs of the buildings

Similarly, among the seven services infrastructure investigated in Table 2b, drainage ranked first with RSI value of 0.660. The second ranked service decay goes to sewage disposal with RSI value of 0.584. This is closely followed by toilet (WC) defects with RSI value of 0.552 ranking third. The least ranked among the service infrastructure with RSI value of 0.428 is electrical installation. On the whole, a combination of both the building structure components and the services infrastructure defects in the housing units shows that drainage system is the most significant defect. This is followed by roof leakage. Thus, the results indicate that poor drainage system accounts for the highest causes of defects on the housing units. This also indicate the reason for other defects namely foundation, sub-structure dampness, floor slab failure and sewage disposal; as the survey affirmed that the housing units investigated were often submerged in water due to flooding during the raining season. Similarly, the second overall significant defect is the roof leakages which also contribute to other defects such as ceiling damage, peeling of wall surface, sagging of beam and floor dampness. Thus the houses are said to be uninhabitable.
