Stability Analysis Of Lukuvir Landslide Using Circular Failure Charts On Sevok – Teesta Bazaar Road, Along NH 10, Kalimpong District, West Bengal

Pranatosh DasMondal

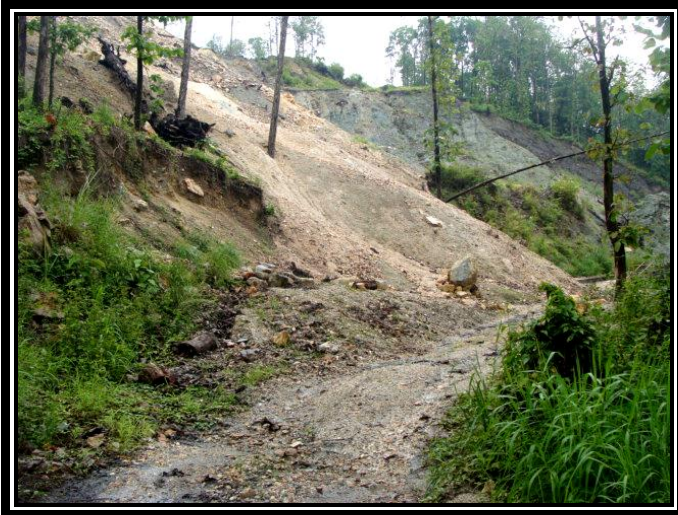
Plate 1: A general view of Lukuvir slide on the banks of the Teesta River

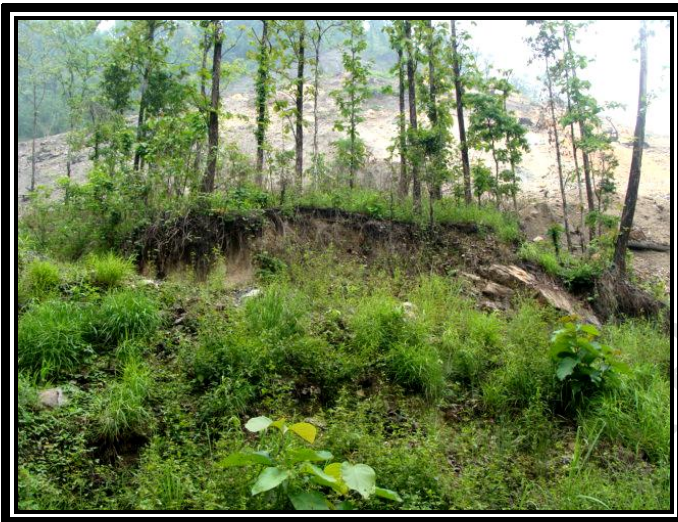
Plate 2: Lukuvir is an old slide with vegetation cover

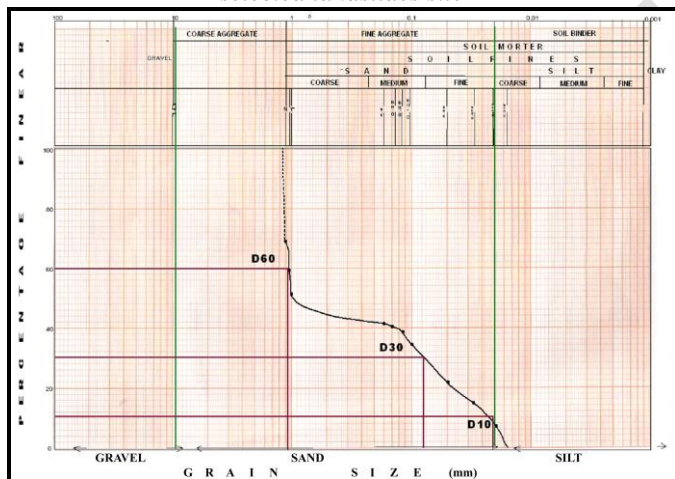
Figure 3: Grain-size distribution Curve of Lukuvir slide

From this analysis we get the total percentage of gravel, sand and silt is 31.7, 86.0 and 14.0 respectively. These are plotted in the triangular diagram to find out the types and nature of soil at the slide area. According to USCS this is loamy sand soil with 31.7%

Cohesion and angle of friction take important role in slope stabilization. Therefore, we consider a visual field inspection of the slide mass in the selected spot as well as consider the typical values of cohesion and soil friction angle for different soils according to USCS. For this purpose grain size distribution (Table -3 and Figure 3) and textural diagram (Figure 4) are use to determine the nature of debris material of the particular site.

From the grain size distribution curve and soil triangular diagram of the slide mass, we find that the soils of the slides area are loamy sand (SM). According to Unified Soil Classification system the range of the soil strength parameters for loamy sand soil (SM) are given below.

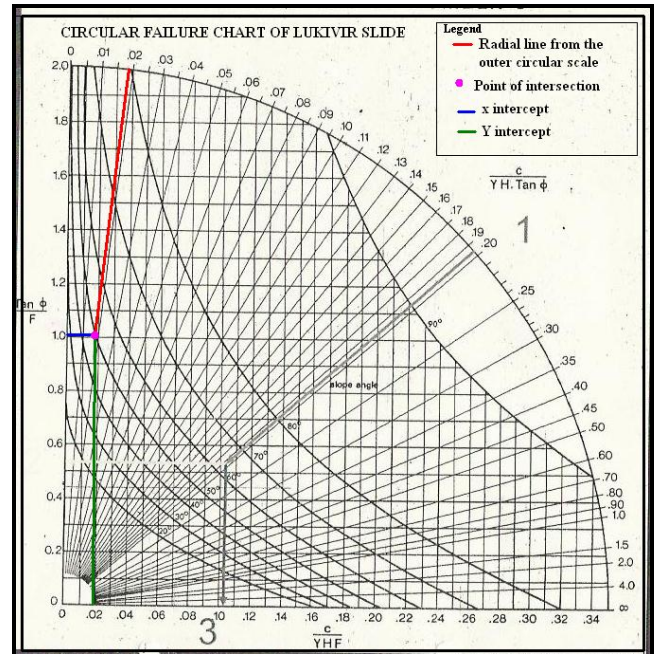
Figure 6: CFC of Lukuvir

Dimensionless ratio
 $= C/\gamma.H.\tan \Phi$
 $= 15000 / (165805 * 80 * \tan 32^\circ)$
 $= 0.018$

The radial line from the outer circular scale is then followed to the particular curve for $\Theta = 50^\circ$

From this we get x intercept = 0.019 and y intercept = 1.01

Value of Y axis = $\tan \Phi / F$
 Value of X axis = $C / \gamma.H.F$
 $\tan \Phi / F = 1.01$
 $C / \gamma.H.F = 0.019$
 $F = \tan 32^\circ / 1.01$
 $= 0.62$
 $F = 15000 / 0.019 * 16580 * 80$
 $= 0.60$

$= (F \text{ value along Y intercept} + F \text{ value along X intercept}) / 2$
 $= (0.62 + 0.60) / 2$
 $= 0.61$

Stability analysis of the kalijhora slide has been carried out using CFC (Figure 6.). The Fs value obtained 0.76, which is less than one. The analysis indicates that the slope is

critically unstable fewer than 25% ground water condition. However when rainfall occurs, the saturation of slope may be more than 25%. The observation has done in pre monsoon period; therefore, during rainy season the slope will become more unstable and fails every year.
