Assessing Suitability Of Abandoned Borrow Pits In Mt. Elgon Region For Economic Activities In Kenya

Department of Civil and Structural Engineering, University of Eldoret,
Eldoret, Kenya

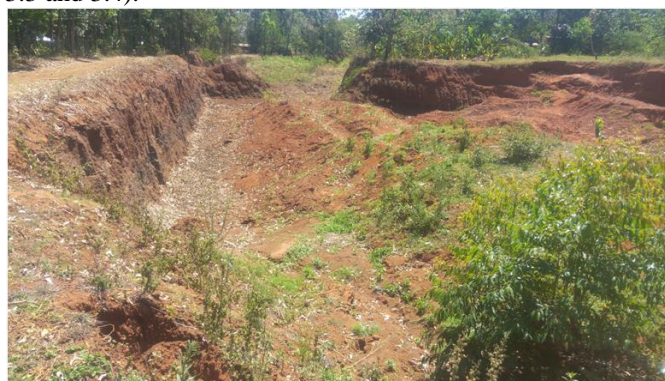
Positive benefits include: water for both domestic and livestock use, water for irrigation, rock material for sell to be eaten by pregnant woman, water for growth of aquatic plants resulting in a wetland and source of firewood (Plate 3.1, 3.2, 3.3 and 3.4).

Plate 3.1: Photo: Borrow pit at Sangura as a source of firewood.

If the borrow pit cannot hold water, there is need to plant trees particularly casurina which will not only assist in

sequestration of CO₂ but also provide firewood for the residents.

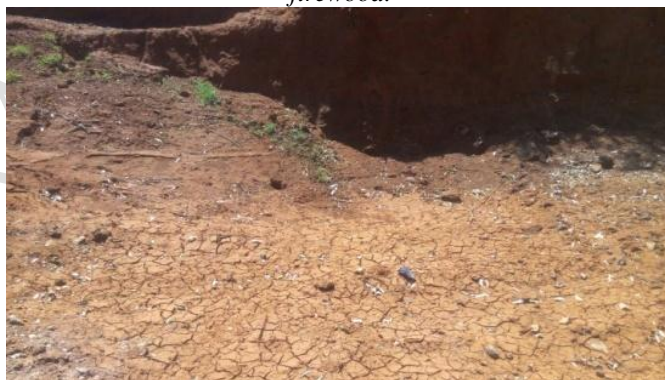
Plate 3.2: Borrow pit at Sangura as a source of water during rainy season

Borrow pits can be used to trap runoff during the rainy season. The water can then be used for irrigation as what is happening in South Sudan (AFRHINET, 2017). Since the borrow pits in the study are close to the homesteads they are good sources of water for irrigation. The problem of mosquitoes can be reduced by having tilapia in water or catfish. Catfish are preferred breed of fish because they can withstand conditions of no water in the borrow pit. In dry areas, the rate of evaporation can be reduced by covering the pond with non-harmful algae (AFRHINET, 2017).

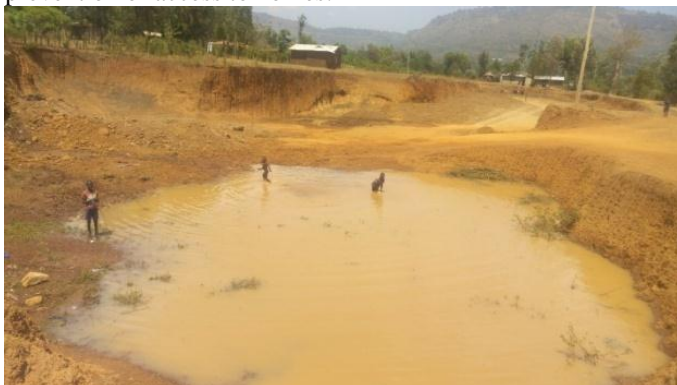
Negative impacts include: drowning of children playing around the pit, collapse of the sides of the borrow pits resulting in swallowing up of arable land or built up area and destruction of electricity poles as shown in Plate 3.3 and prevention of access to homes.

Plate 3.3: Accumulation of water at Kimabole that can result in drowning

These borrow pits are close to houses of community. The borrow pits were initially agricultural land and now they have been left bare with little re-growth of grass. Some borrow pits have steep sides which are susceptible to collapse or sliding and hence the need to trim to a stable slanting position. Water in the pond can be a risk to both human and livestock. Such places become breeding places for mosquitoes and hence the need to introduce fish.

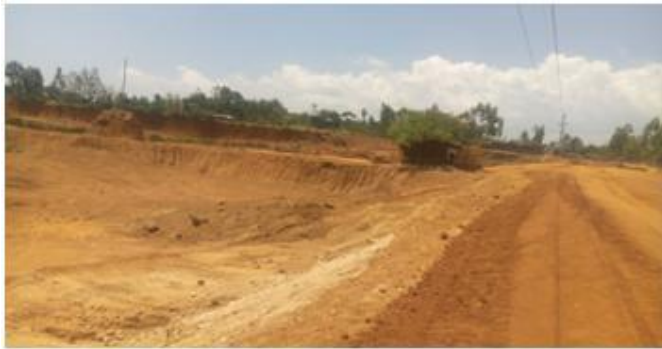
Plate 3.4: Electricity poles at Kazambeli borrow pit

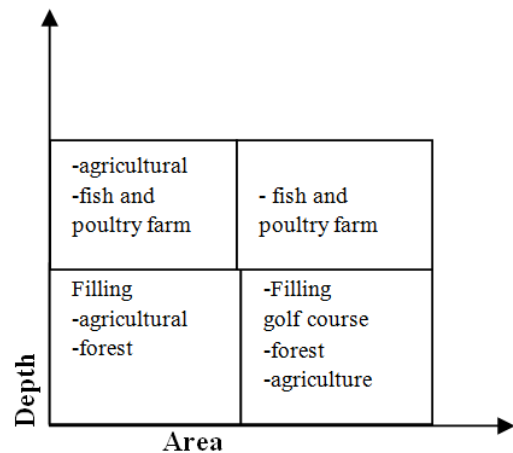
Figure 3.1 Several Economic uses of Borrow pits based on area and depths

If the bottom of the borrow pit intersects the ground water depth, it should be left so as to pond water and hence act like a dam. A borrow pit with water will assist in sequestration of CO₂ in the atmosphere and thus assisting reducing the effects of climate change on communities. A borrow pit with water and of sufficient surface area can be use for water sport where people can come and compete in boat rowing.

In addition, a borrow pit with water and of shallow depth, can be used for mixed farming for fish and chicken which are good source of proteins. Borrow pits with more than 20% soil content is good for holding water (LSU sea Grant, 2006). The ponds size range from 0.75 to 2.0 acres. These sizes are good for ponds as larger areas make them sustainable and with less management. Fish thrive well at depths of around 2 metres which means that the three sites are very good for fish farming. Kazambeli and Kimabole borrow pits have silt or clay content of more than 20% and hence good at holding water.
