Adequacy Of Road Furniture Within The Major Highways In Minna Metropolis, Niger State, Nigeria

IDOWU, Olusegun Owoeye

Department of Urban and Regional Planning,
Federal University of Technology, Minna Niger State

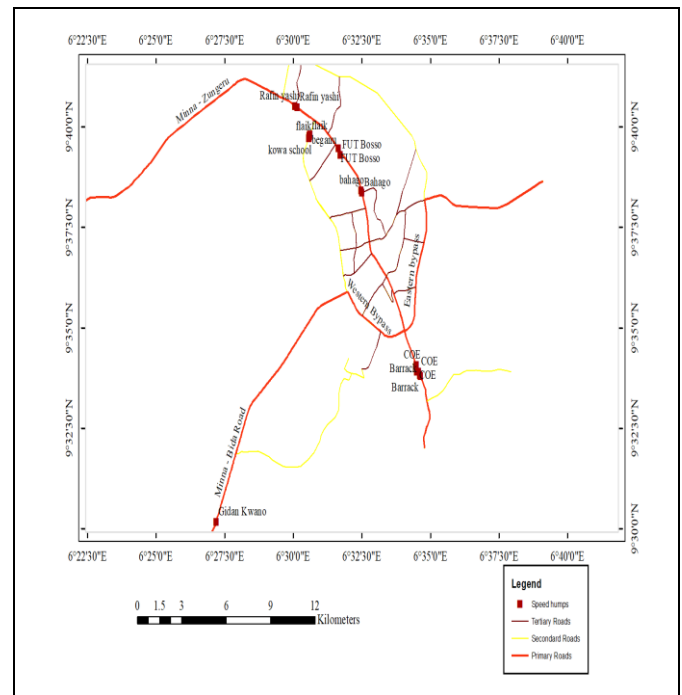
Figure 3: Distribution of Speed Humps along the Major Roads in Minna

25 Speed humps were observed along the major roads. 11 were observed to be in poor condition while the remaining 14 were good. Table 3 shows the locations and conditions of the speed humps and figure 3 shows their distribution. The Speed Humps along the roads were indicated to be randomly distributed. The nearest neighbor ratio was obtained as 0.91, the z score as 0.90 and the p value as 0.37. Therefore, the pattern appears to be significantly random. The observed mean distance was obtained as 2588m and the expected mean distance as 2857m.
